**Type-B Accident Investigation Report  
of the January 20, 1998, Electrical Accident  
at Casa Grande Substation, South of Phoenix, Arizona**

**Western Area Power Administration  
U.S. Department of Energy**

This report is an independent product of the Type-B Accident Investigation Board appointed by Michael S.Cowan, Chief Program Officer, Western Area Power Administration.

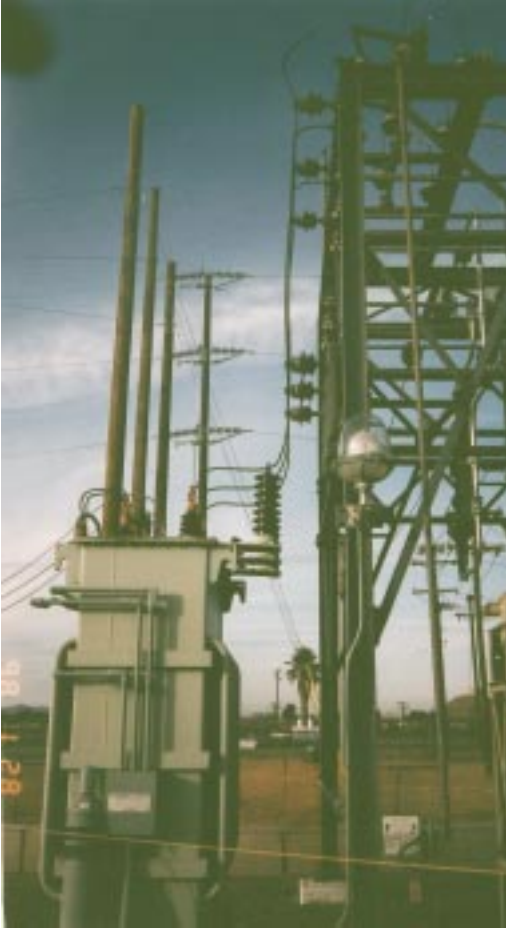
The grounding transformer KZ3A and jumpers scheduled to be removed to place an isolation barrier on the west-end. The picture also shows Disc. SW. 1421 open, locked and tagged

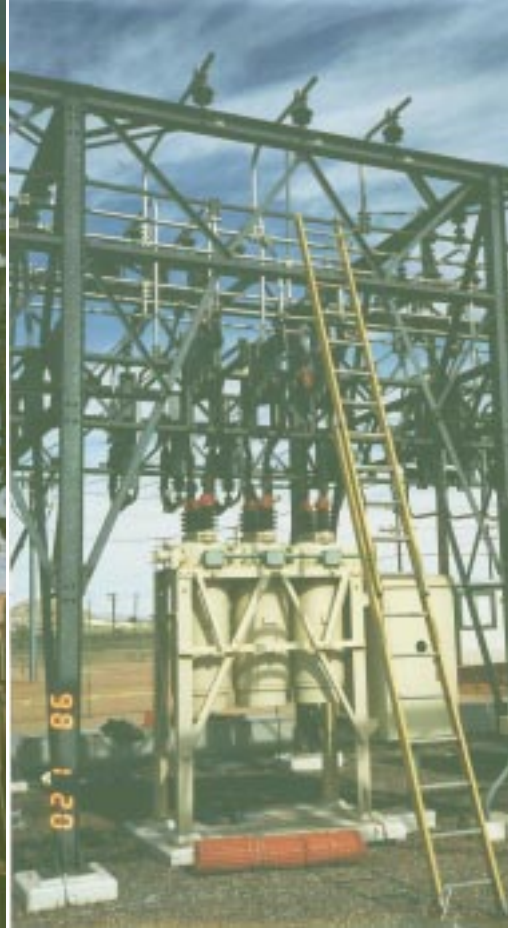
### **BAY Z1 NORTH VIEW**

Showing the location where work was to be performed, which included removal of three pieces of stub bus

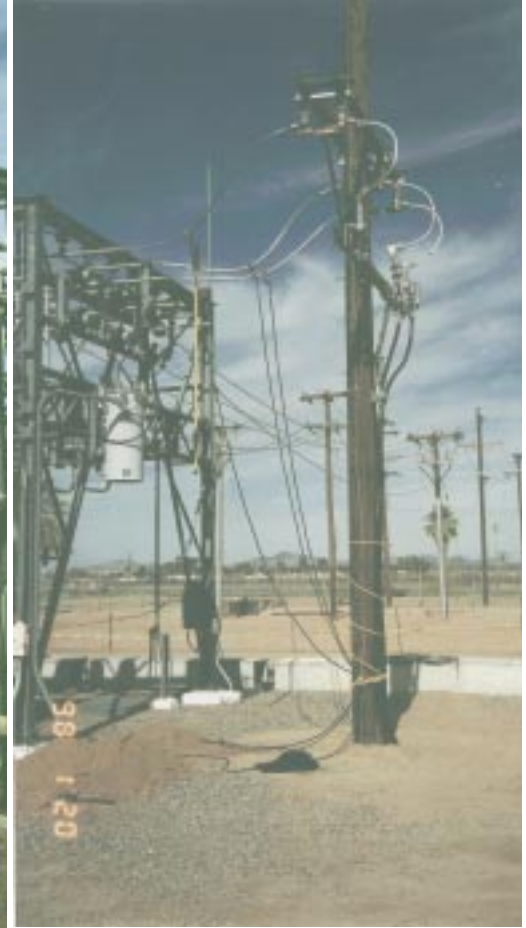
Temporary feed located east of the 12.47-kV bus structure. The picture also shows the location of personal protective grounds on the east side of the main bus.

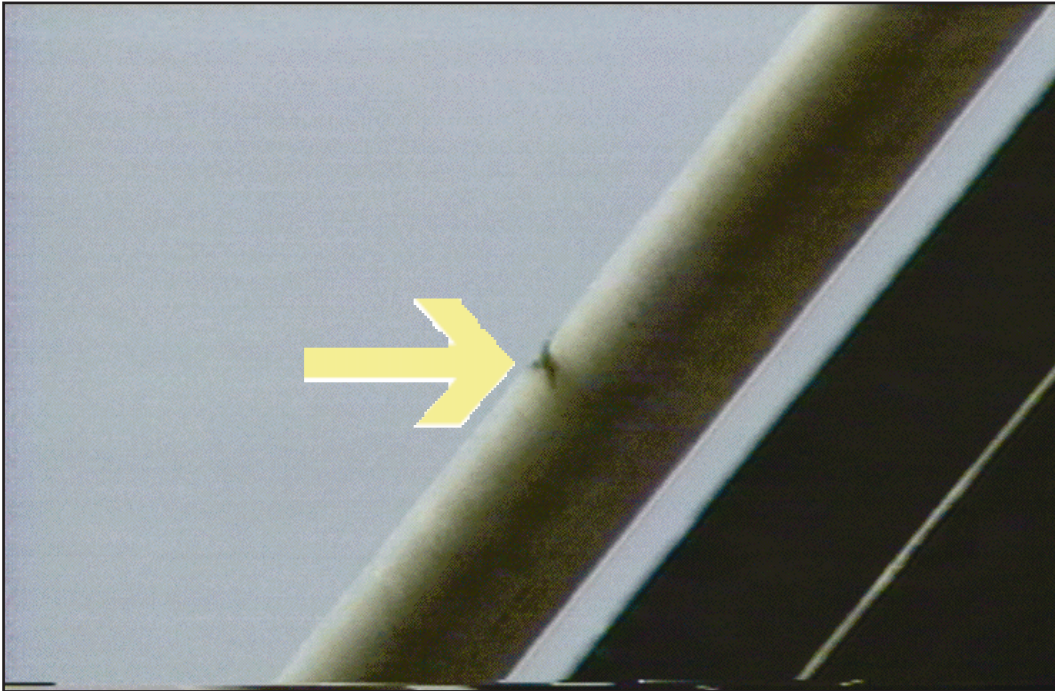
## **EXHIBIT B**

Electrical burn mark on south phase of 12.47-kV  
transfer bus

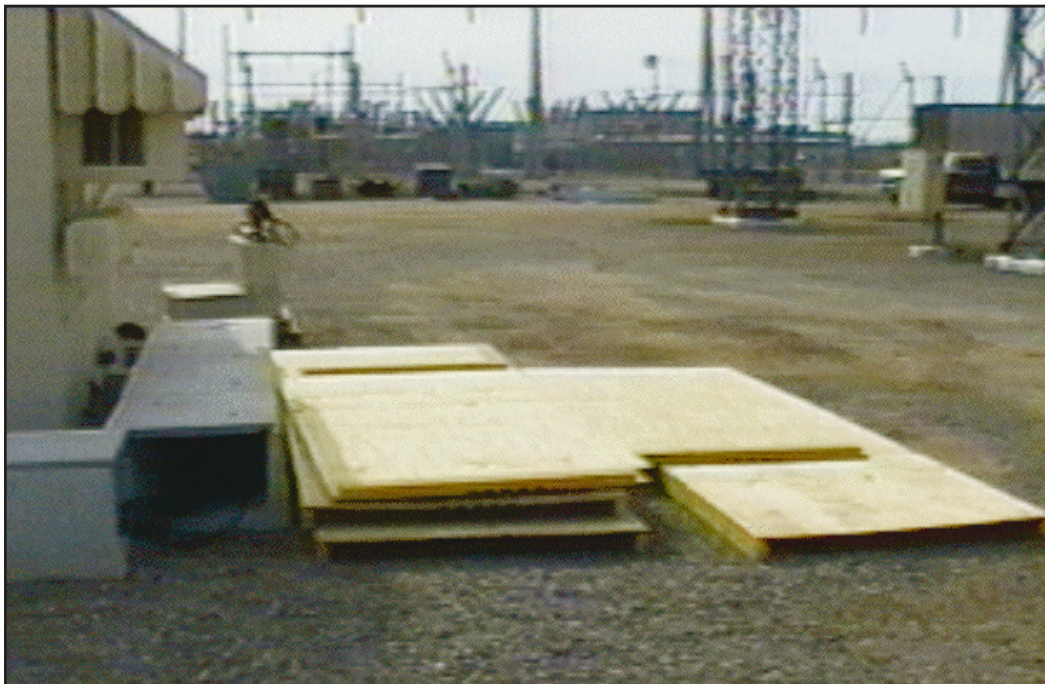
## **EXHIBIT C**

View of the prefabricated isolating barriers to be  
placed along the south and west sides of the  
12.47-kV bus structure

This meeting, according to the minutes, was comprehensive and included some issues pertinent to the specific job. Placement of plywood barricades (Exhibit C) on portions of the south and west sides of the bus structure was discussed. Discussion items included working in close proximity to energized facilities, the need for a JHA, maintaining safe working distances, hot line orders (HLOs), and proper grounding procedures, including documentation of locations of grounds on the Special Work Permit (Appendix C).

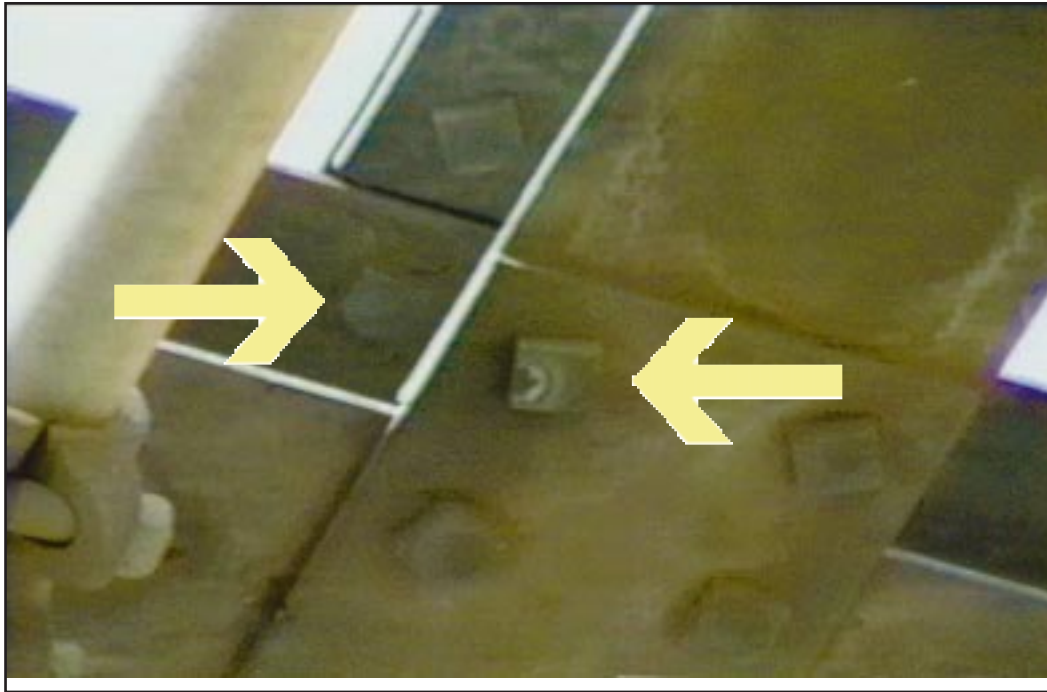
## **EXHIBIT D**

View showing a burn mark on the bottom of the bolt head located on the 12.47-kV steel structure

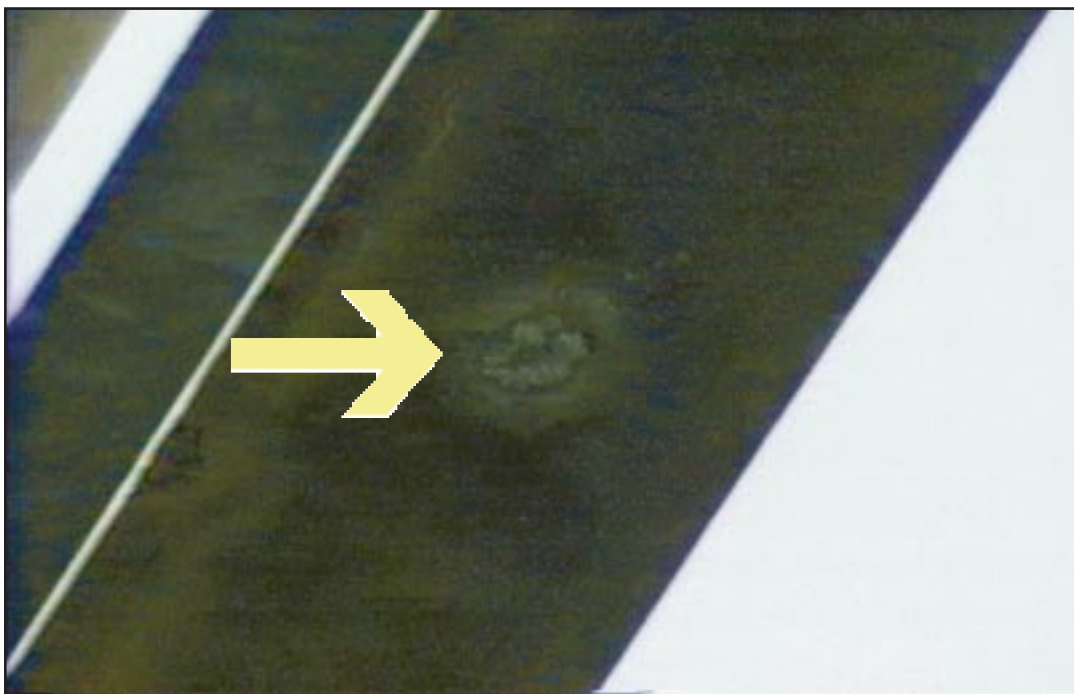
## **EXHIBIT E**

View of a burn mark located on the bottom section of the steel beam

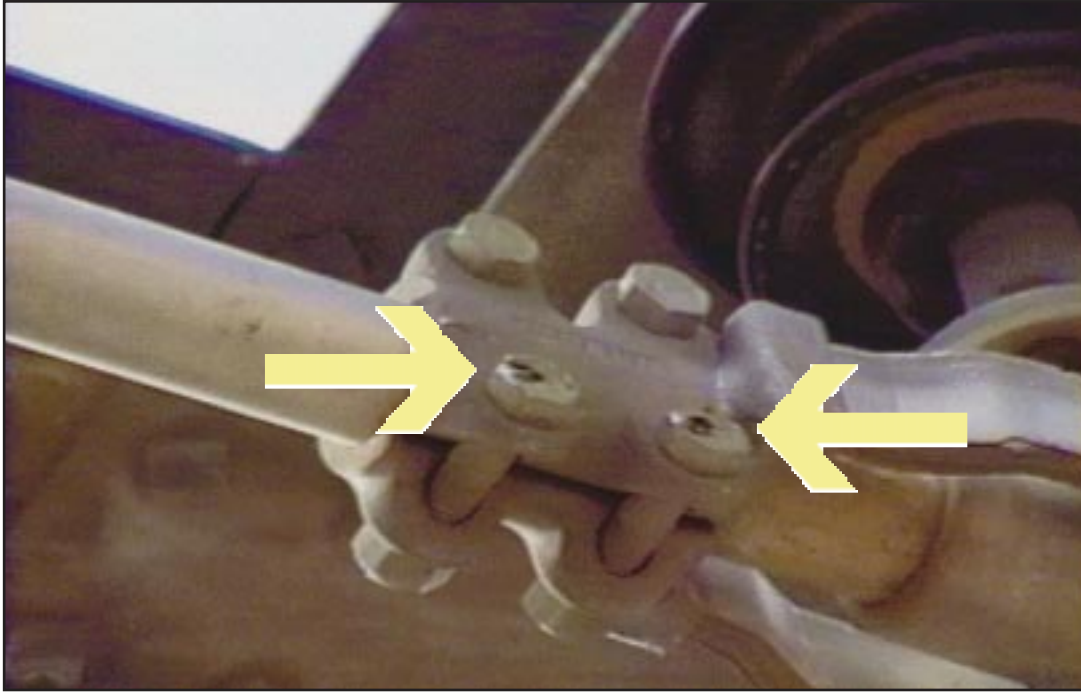
## **EXHIBIT F**

View of burn marks on the bolts located on the  
center phase transfer bus

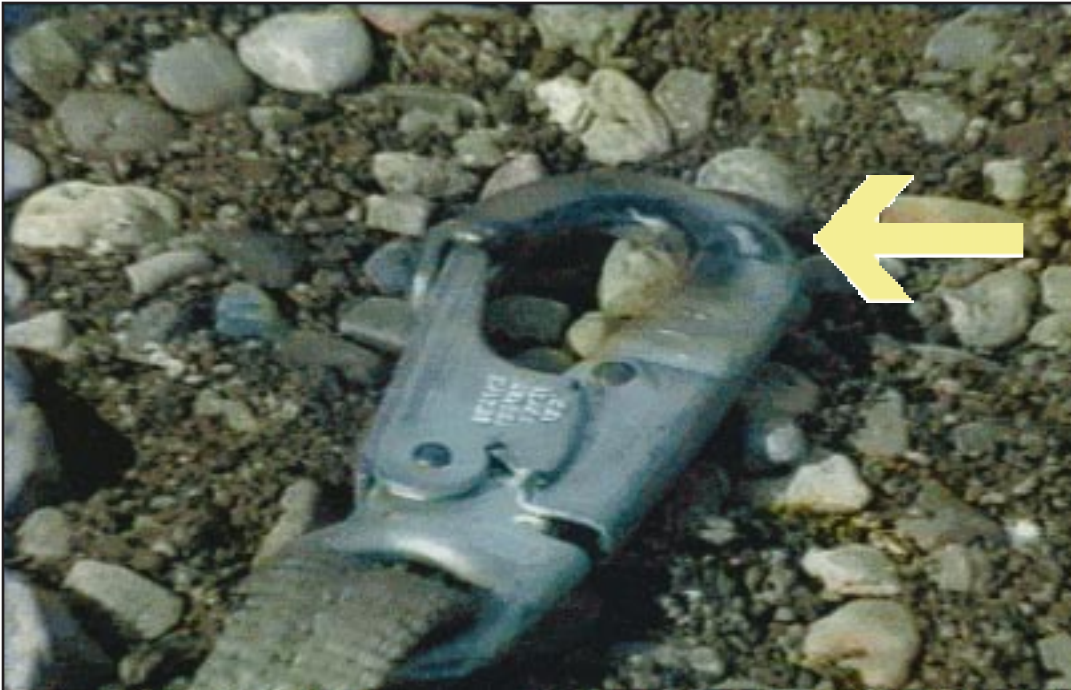
## **EXHIBIT G**

View of electrical burn mark located on the victim's  
lanyard

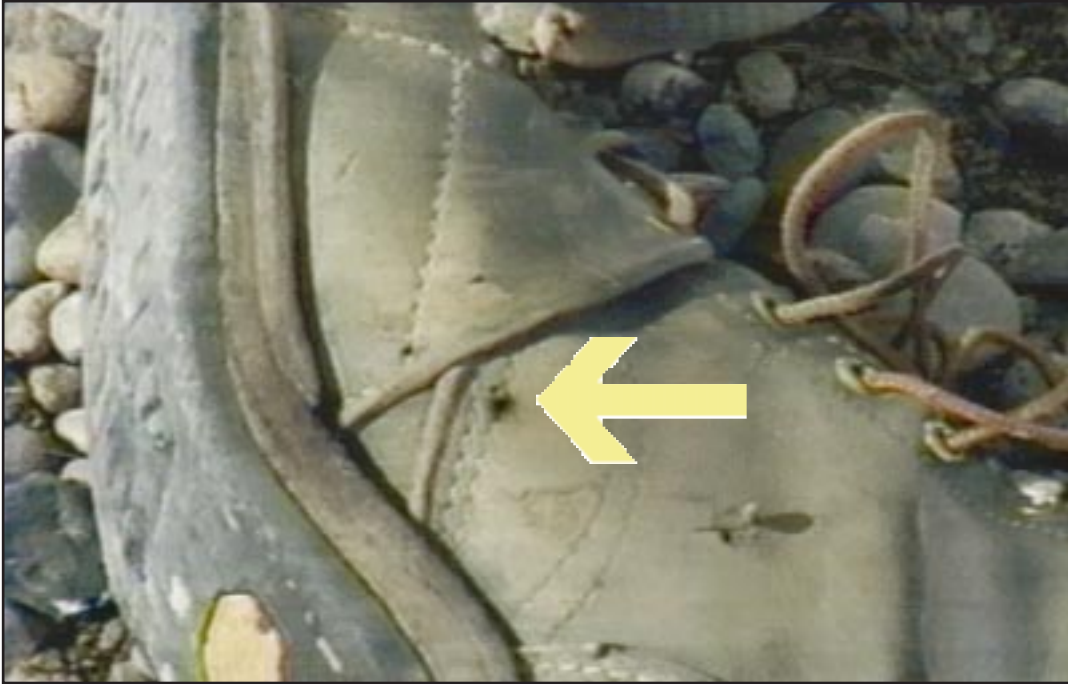
## **EXHIBIT H**

View of the victim's right boot showing the electrical  
burns

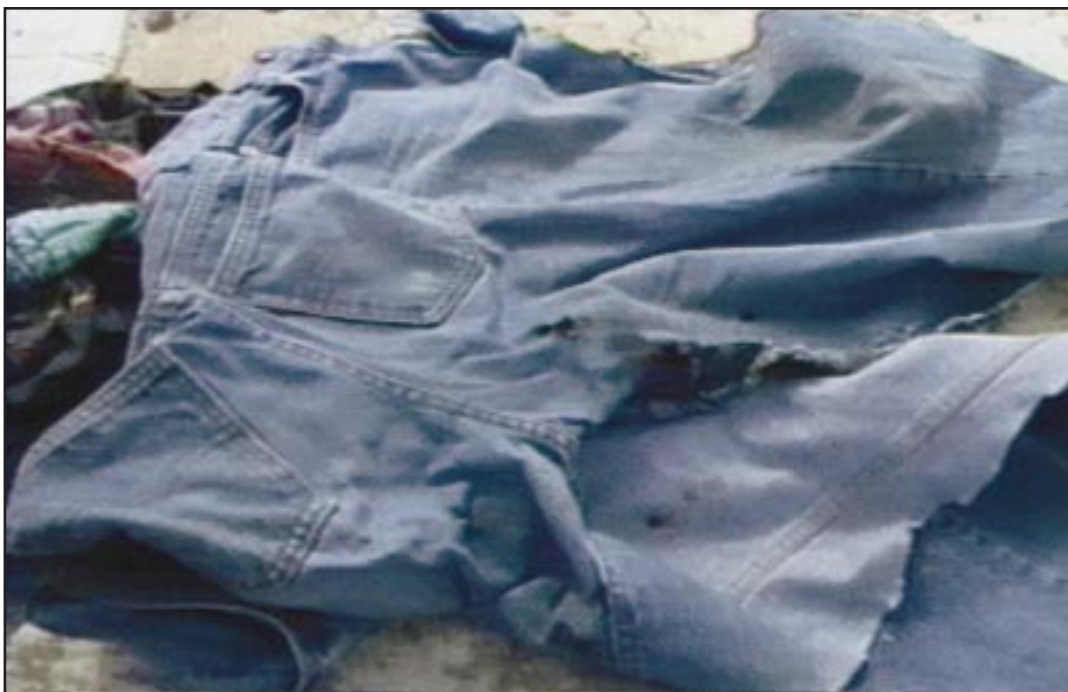
## **EXHIBIT I**

View showing burn marks on the victim's pants
